# ENGINEERING DEPARTMENT.

TWENTY-EIGHTH ANNUAL REPORT

## CITY ENGINEER, BOSTON,

FOR THE YEAR 1894.

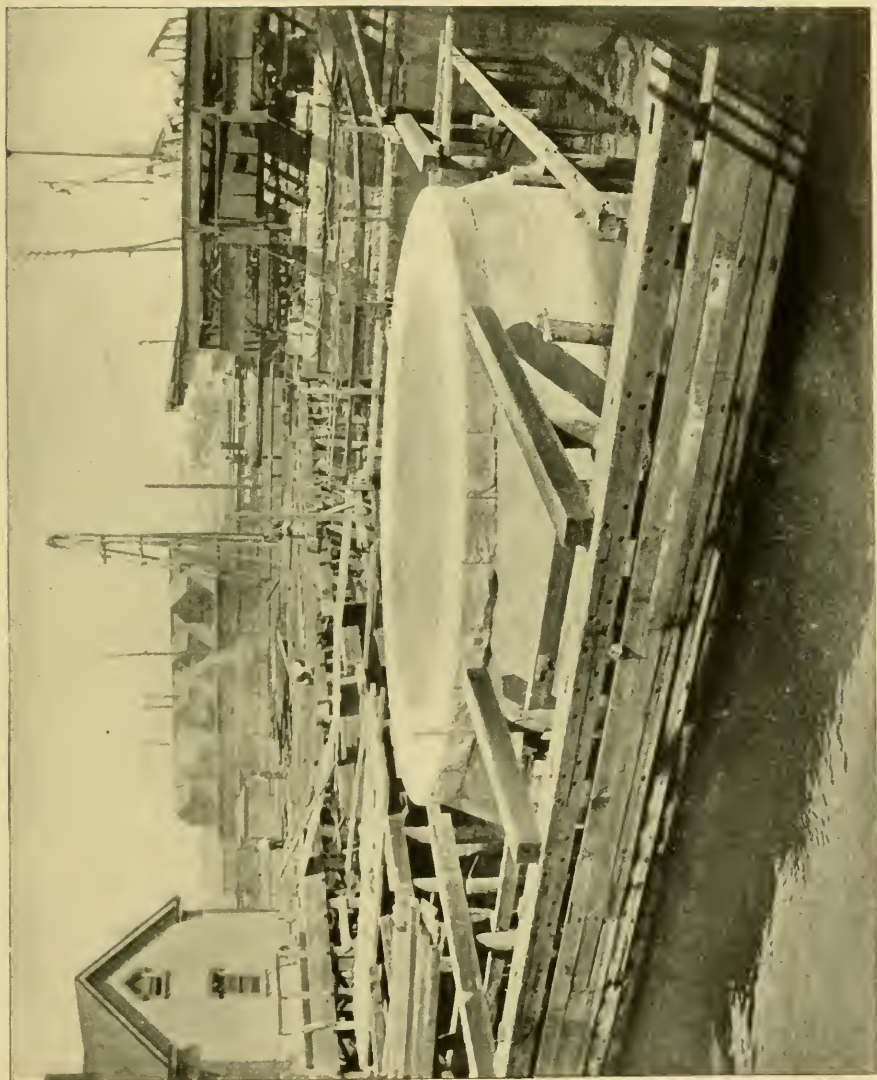
DOVER-STREET BRIDGE, FOUNDATION PIER FOR DRAW.

After the piles were driven and cut off, a curbing of sheet piling was constructed around the space to be occupied by the concrete foundation, and filled with Portland cement concrete to grade 0. Below grade — 2 the concrete was deposited in the water through iron chutes; above this point it was deposited while the curbing was free from water, and was carefully rammed and levelled to form a good bed for the lower course of masonry. The concrete was made of one part Portland cement, two parts of sand, and five parts of broken stone or pebbles — all parts by measure.

Above grade 0 the piers are made of granite, laid in

mortar made of one part Portland cement and two parts sand. The courses in the pier are 2 feet thick. The lower course of each pier is made of two lines of stretchers, with closure stone at each end of course. The beds of this course are dressed or split to lay not more than 1-inch joint, the builds dressed to lay  $\frac{1}{2}$ -inch joint, and the vertical joints to lay  $\frac{1}{2}$ -inch joint for one foot from the face of pier, and 1-inch to 2-inch joints for the balance of the joint.

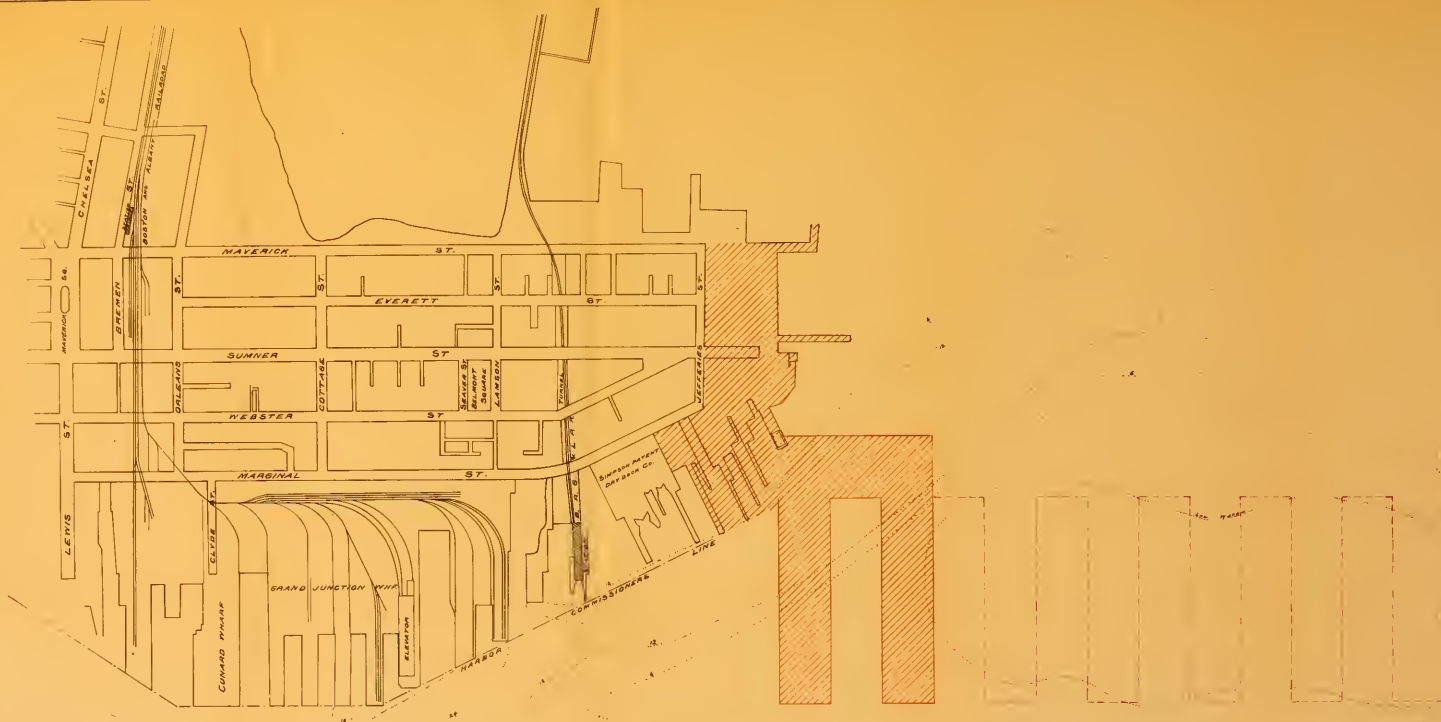
CITY OF BOSTON  
ENGINEERING DEPARTMENT  
SKETCH SHOWING PROPOSED LOCATION  
OF  
DOCKS ON BIRD ISLAND FLATS

The plan contemplates the closing of the present channel between East Boston and the flats and the taking of several of the existing wharves. The estimated cost (exclusive of roadways, buildings, etc.) for constructing two piers, to be 1,000 feet in length by 250 feet in width, with a filled area 300 feet in depth at the head of the docks for roadway, storage of cars, etc., with no allowance for land damages, is \$850,000.

The assessed value of the land and docks which it would be necessary to take is \$138,000.

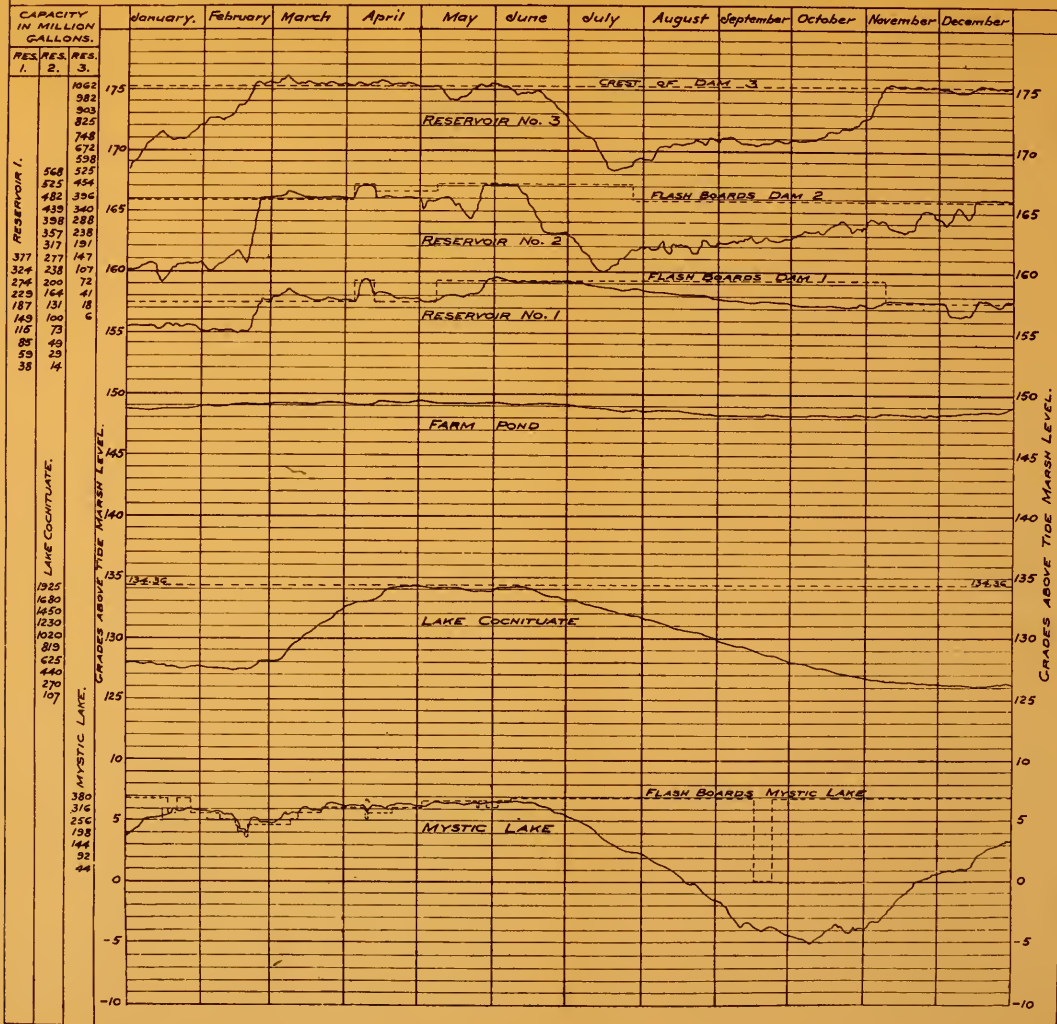
Diagram showing the heights of Sudbury River Reservoirs Nos. 1, 2 and 3, Farm Pond and Cochituate and Mystic Lakes during the year 1894.

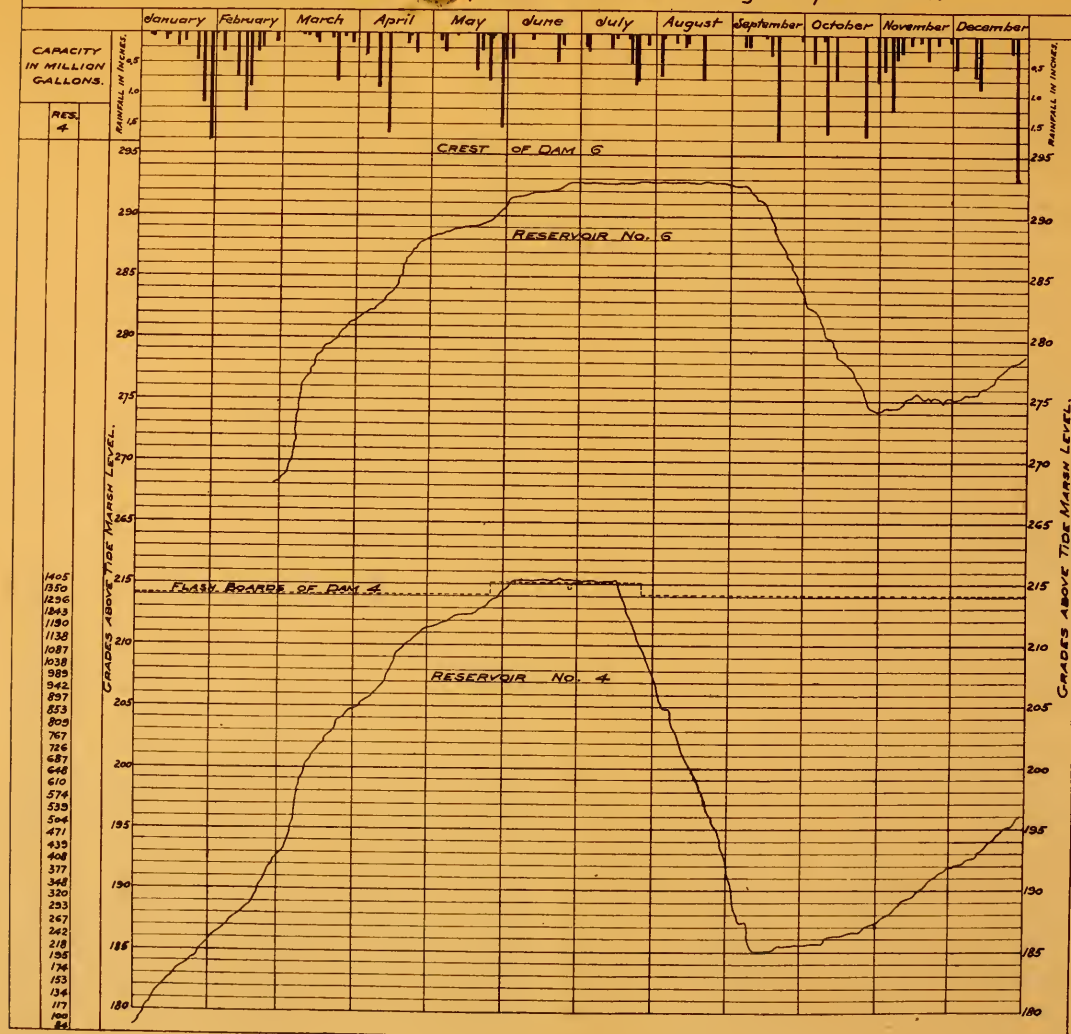
Diagram showing the heights of Sudbury River Reservoirs Nos. 4 and 6, and the Rainfall on the Sudbury River Water Shed during the year 1894.

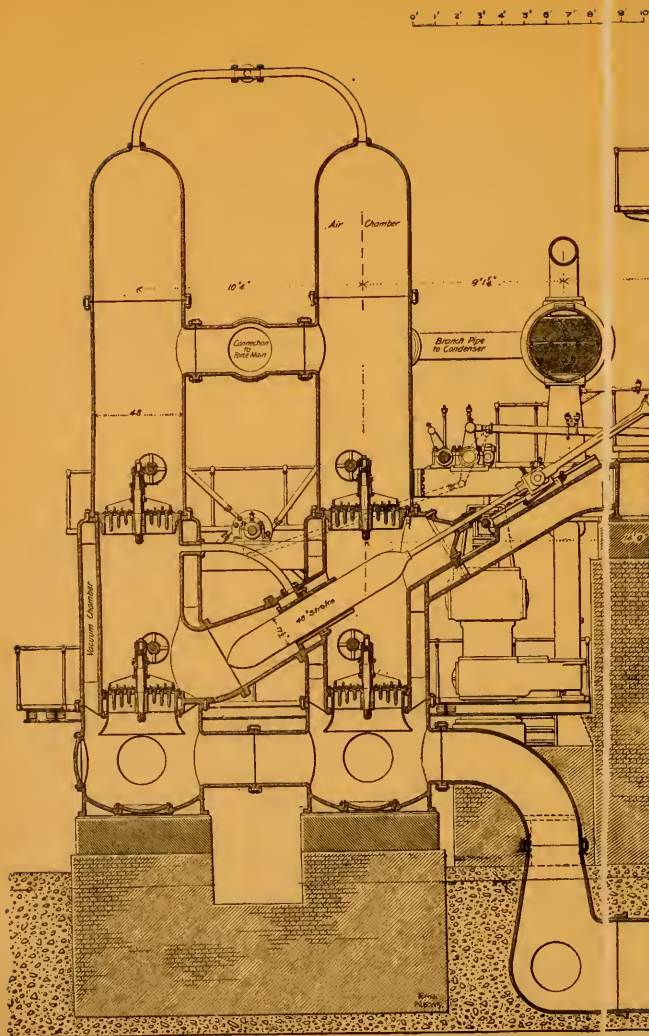
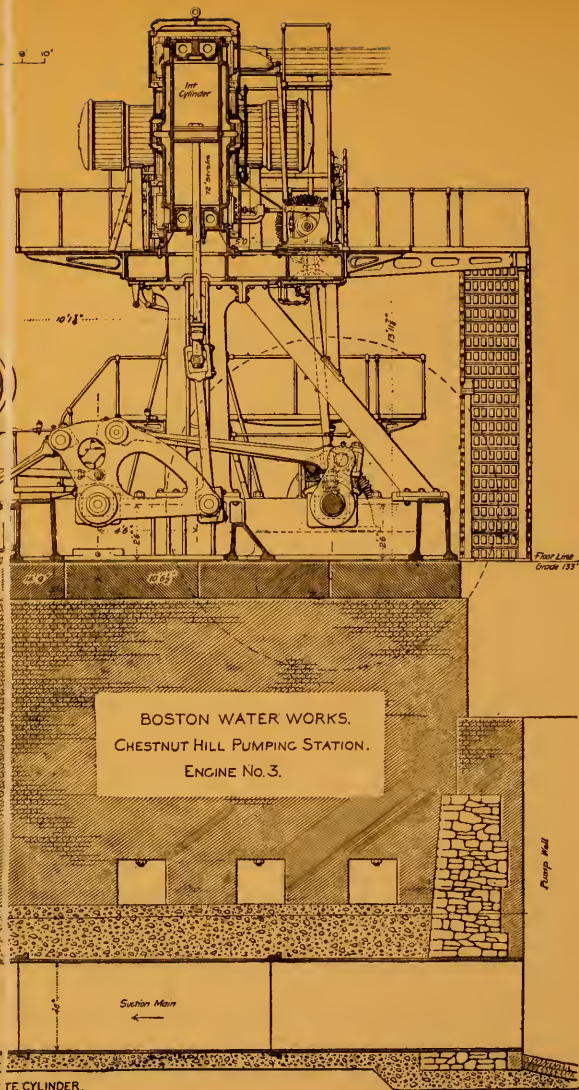
VERTICAL SECTION THROUGH INTERMEDIATE CYLINDER.

The engine cross-heads work on guides cast in the vertical columns. The motion is transmitted from the cross-heads by links to beams or rockers carried in pedestals on the bed-plate of the engine. From these beams the connecting-rods work off in one direction and the pump links in the opposite direction, but inclined at an angle of about 30 degrees from the horizontal. The leverage of the various pins in the beams is such that the stroke, which is six feet in the case of the steam pistons, is reduced to four feet for the pump plungers, which is also the amount of the double throw of the cranks. The crank-shaft has three cranks set at angles of 120 degrees, the low-pressure crank leading, followed by the intermediate and high-pressure cranks.

The shaft is carried in four adjustable four-box pedestals, with overhung end cranks. Between two of these pedestals is the fly-wheel, and between the other two the gear for driving the cam-shaft. There are three double-acting inclined pumps, having plungers 17.5 inches in diameter and of 4 feet stroke. The pumps are seated on foundations at a

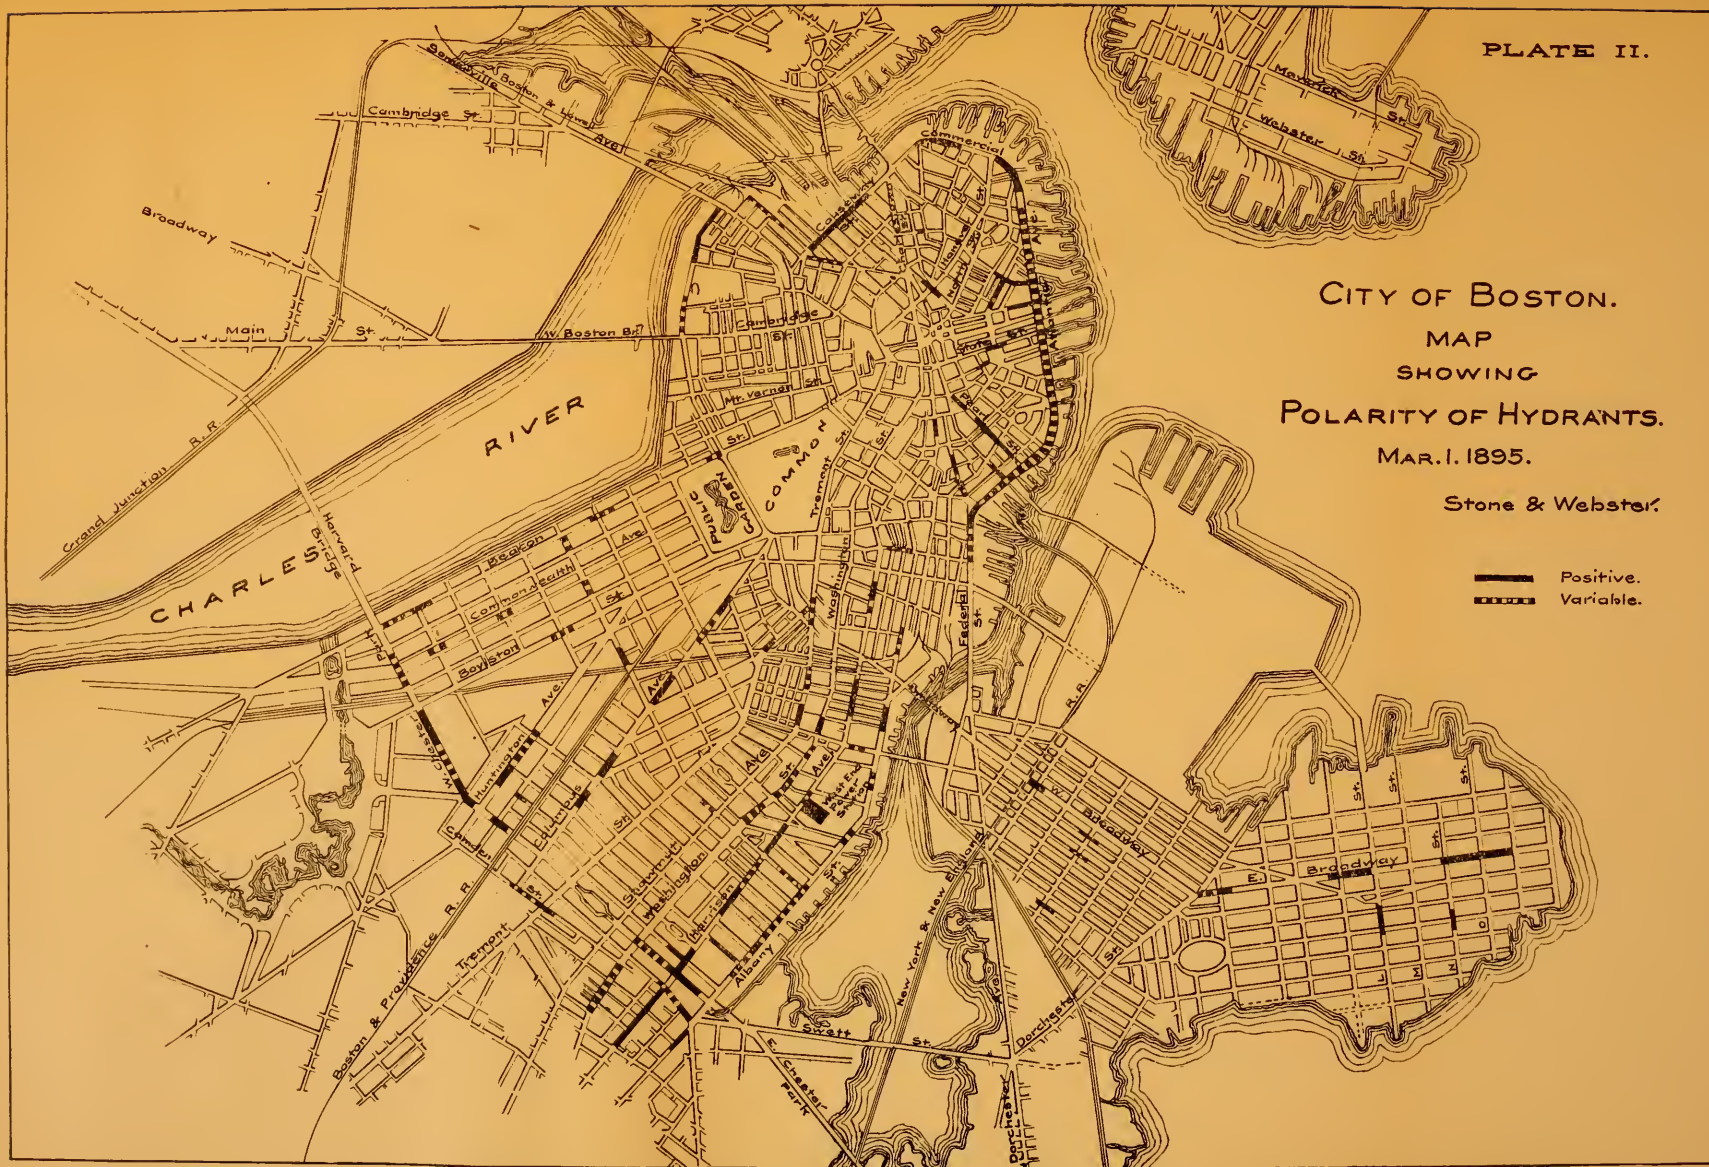
CITY OF BOSTON.  
MAP  
SHOWING  
POLARITY OF HYDRANTS.  
MAR. 1. 1895.

In the twelve places where satisfactory observations were made the potential between the pipes and the surface of the ground, and also the

potential between the pipes and the earth at the base of the hydrants, was found always to have the same sign as the potential between the pipes and the ground immediately surrounding them.

This would seem to prove conclusively that the method regularly adopted gives the correct polarity of the reading, and approximately the correct value.

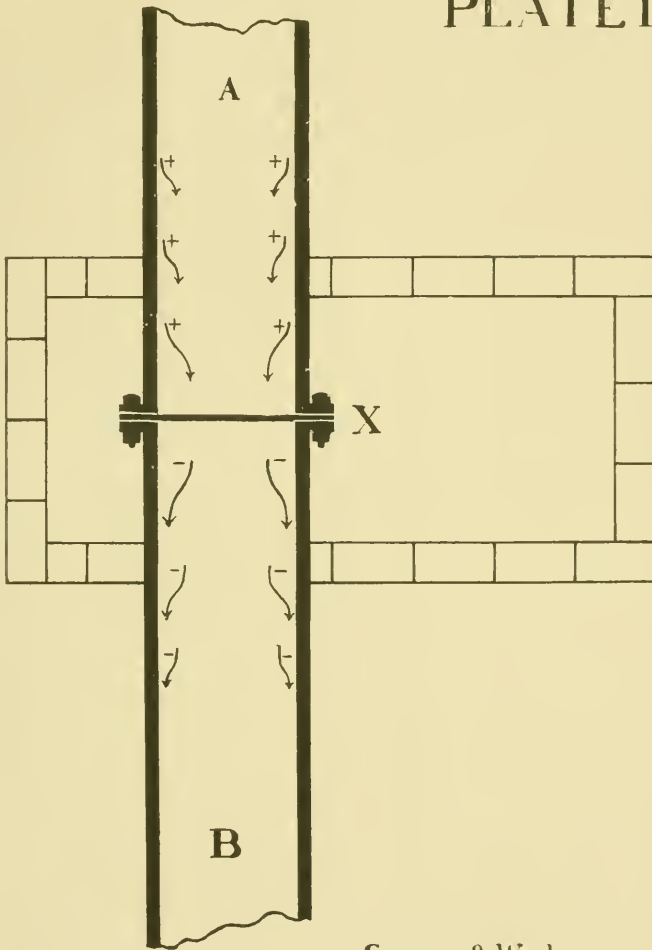
PLATE III.

Plate III. shows a section of pipe which was examined under our

direction in a city where considerable trouble had been experienced from electrolytic action. This particular piece of pipe was situated at a distance of some two miles from the nearest electric power-station, and it so happened that the tendency of the current was to flow from the adjacent railway system to Section A, and thence to B, in the direction of the power-house. At X there was a rubber gasket, and under the bolt heads were cotton washers, so that Section A was electrically insulated from Section B. This made it necessary for the current to pass from the inner surface of A to the water, and then back again to the surface of B, in order to get around the joint.

When we first noticed the rubber gasket, this condition of affairs was expected; and, upon inspecting the inside of the pipe, it was found that the inner surface of A was covered with scales, and pitted in many places to a depth of 1-16 of an inch, while the inner surface of B was as clean and smooth as upon the day it was first laid.

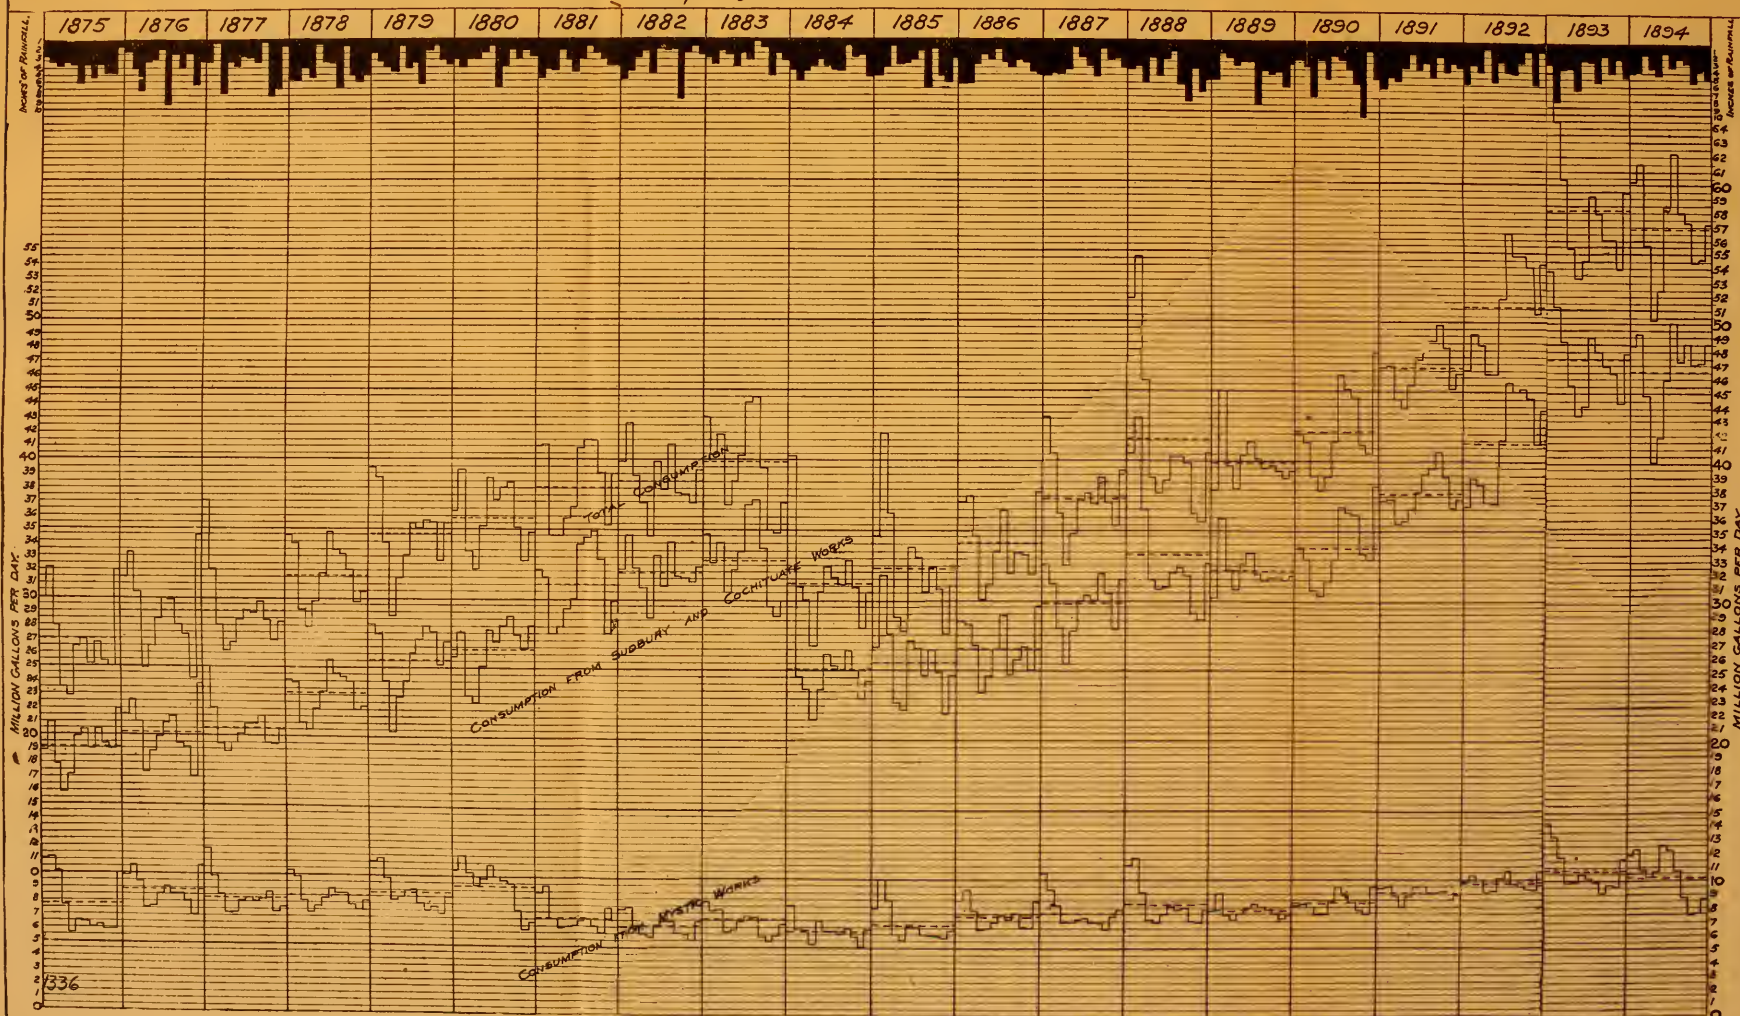
Diagram showing the rainfall and daily average Consumption for each month.
